NATIONAL BUREAU OF STANDARDS REPORT

**STRUCTURAL
PERFORMANCE
TEST:**

neal mitchell
housing system

Interim Report

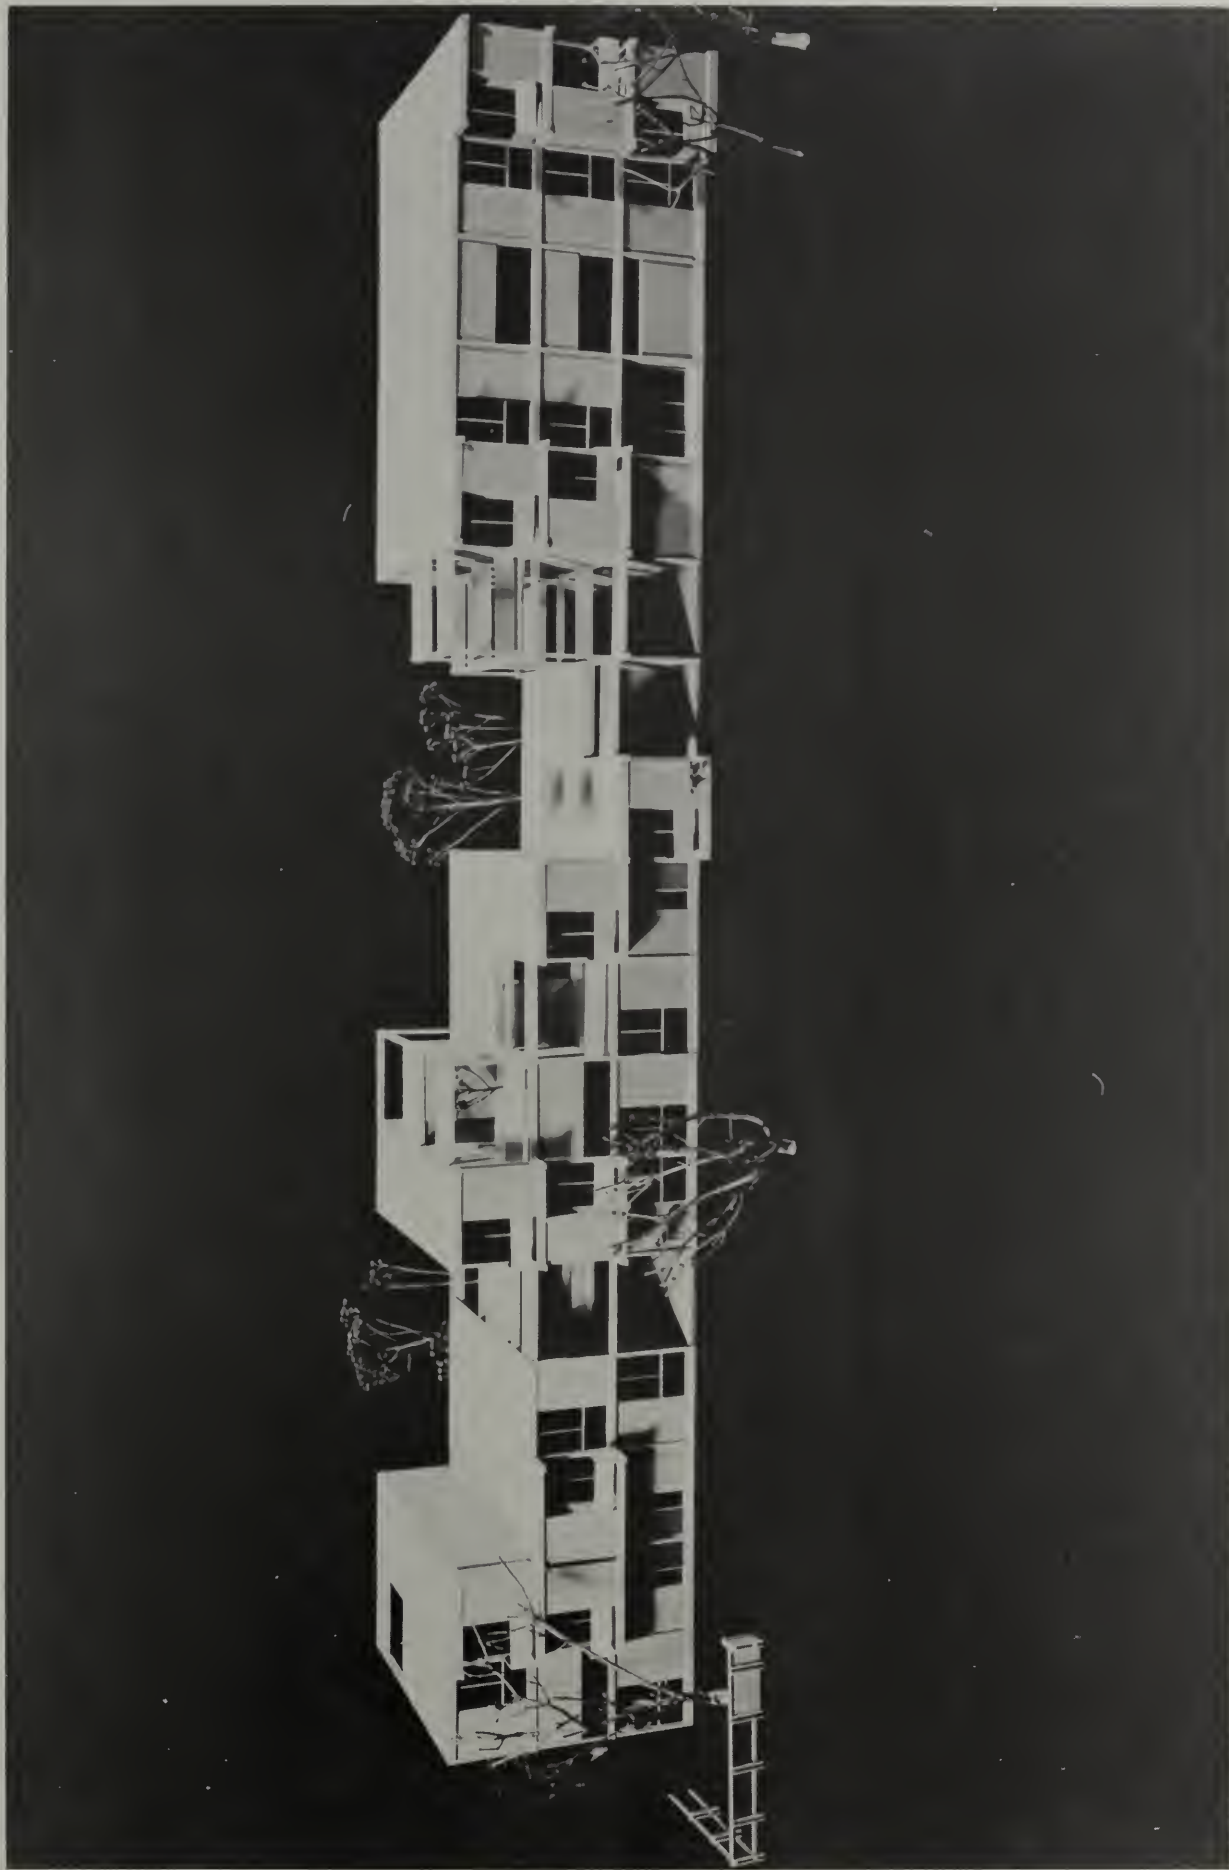
Fig. 5.1 Typical complete structure

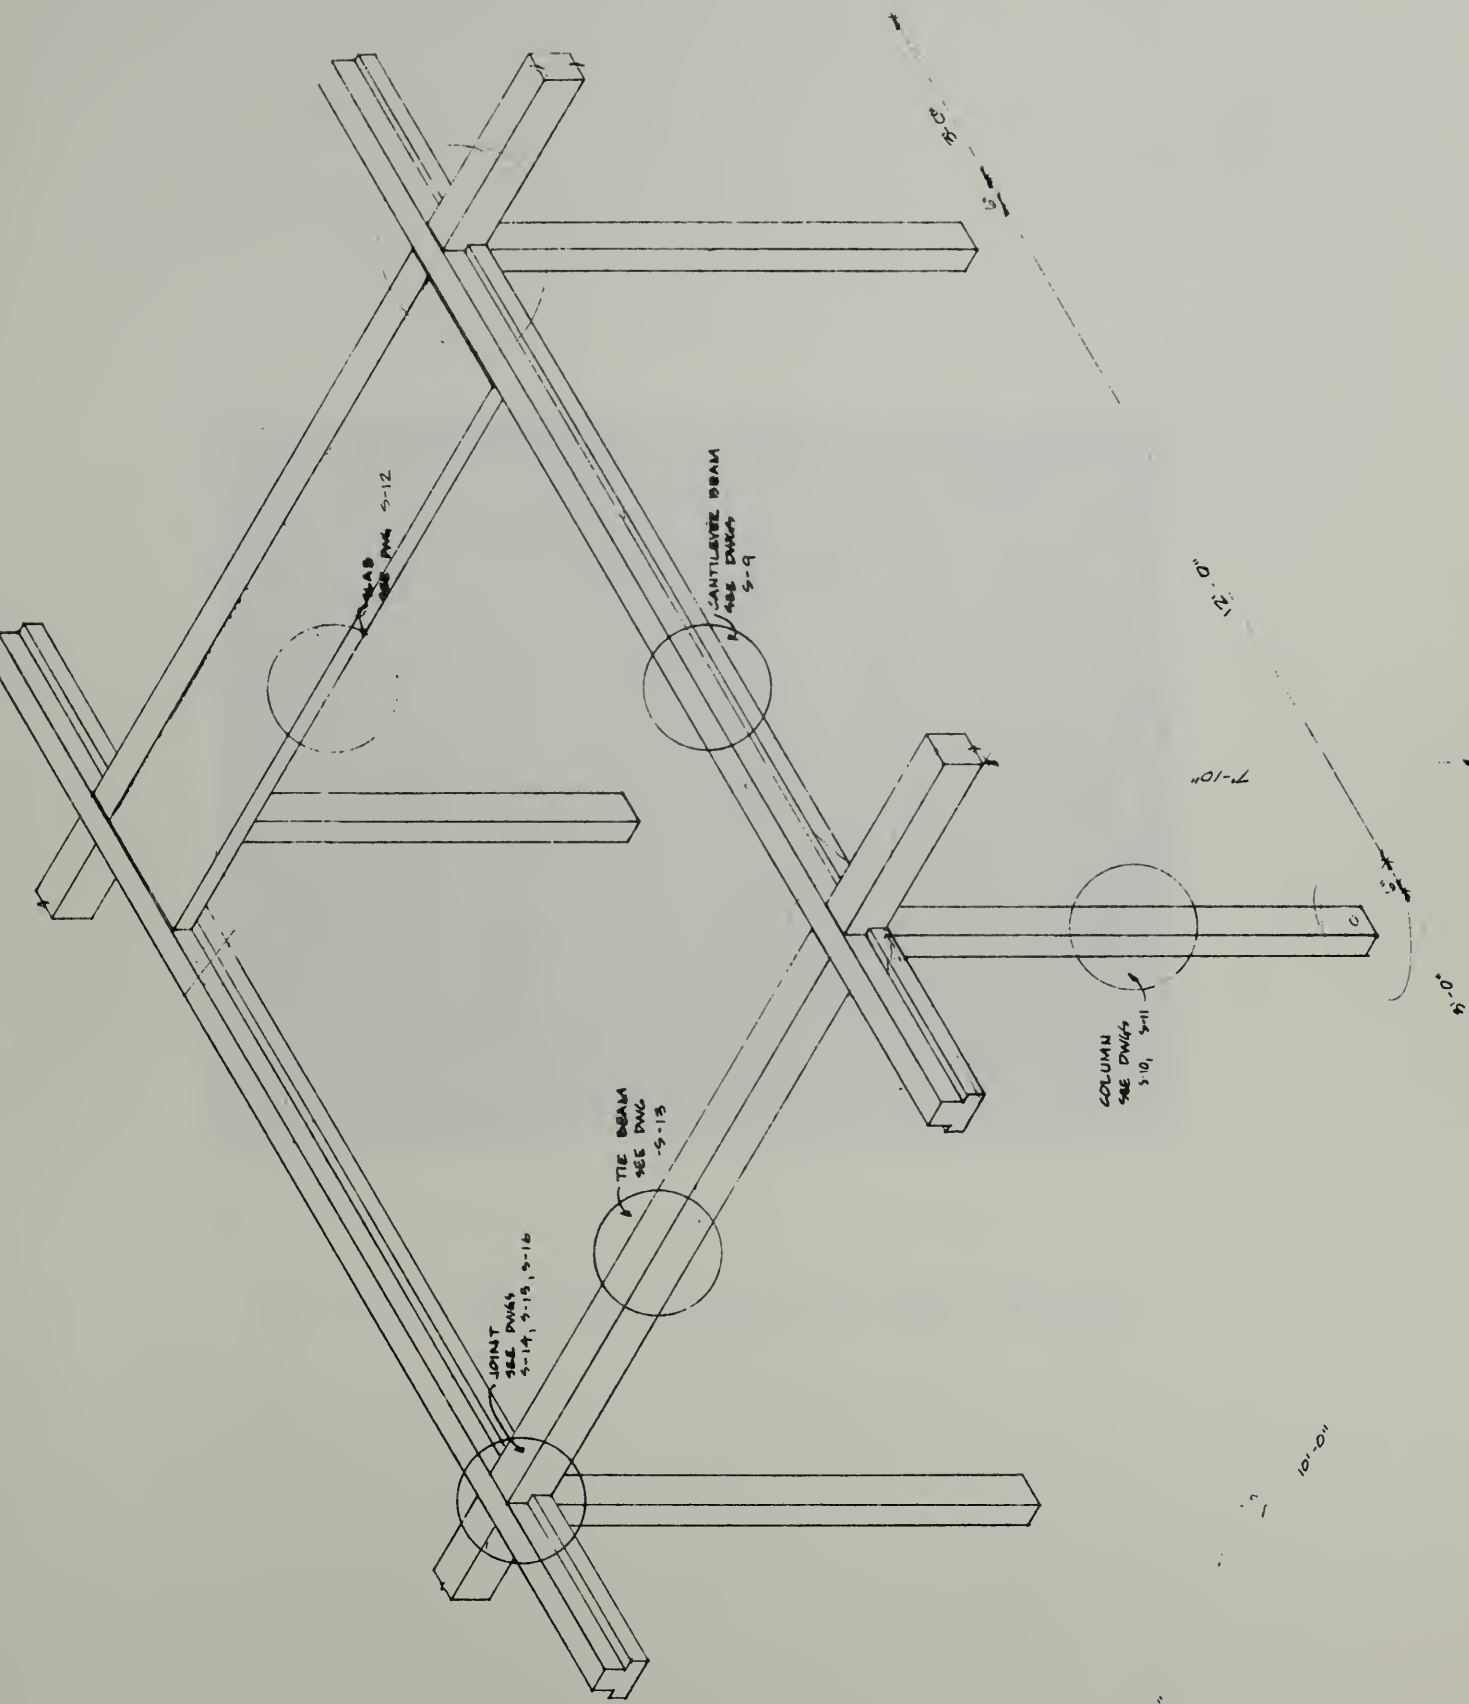
Fig. 5.2 Assembled structural frame

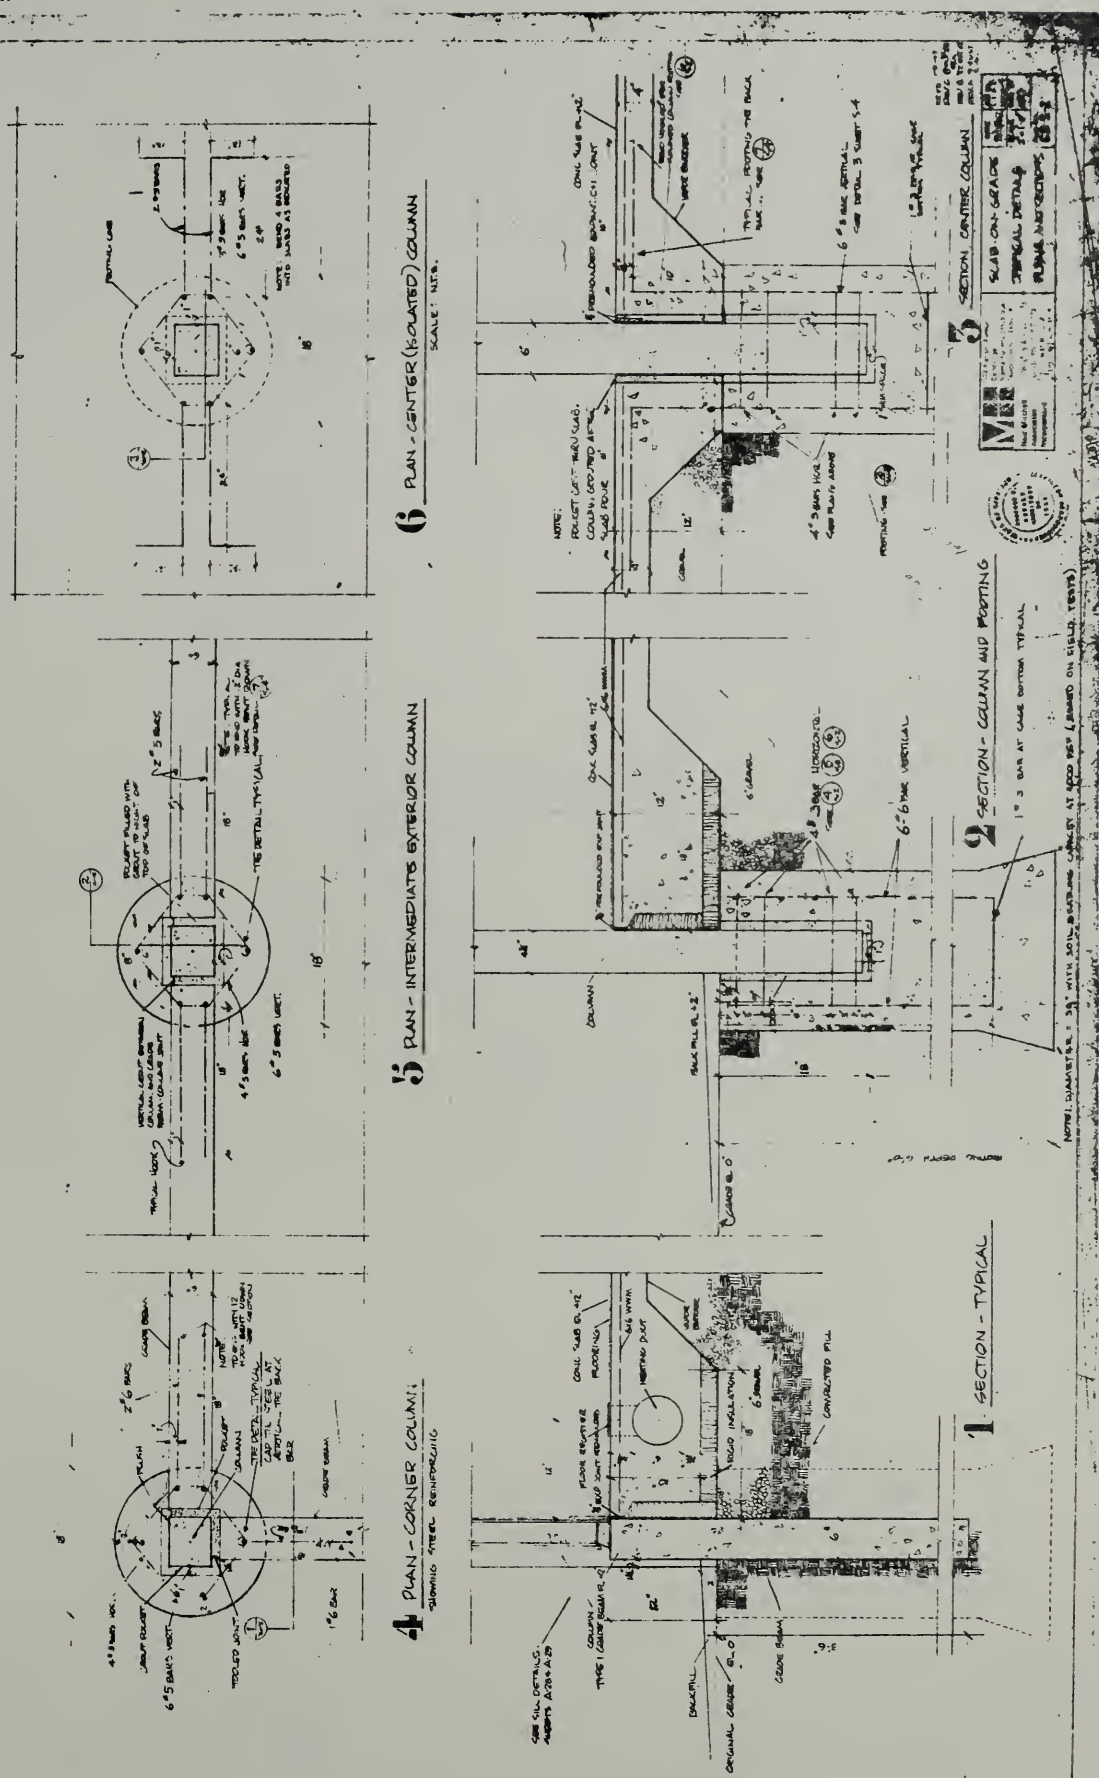
Fig. 5.17 Foundation plans

Foundation plans are shown in Fig. 5.17.

Column foundations in the proposed building extend to a 6' depth below grade for exterior column, and to 3' depth below the top of the floor slab for interior columns (See Fig. 5.17). Exterior column footings are also tied into the perimeter wall for added fixity. This configuration will provide some degree of fixity at the column base, the degree depending on prevailing soil conditions.

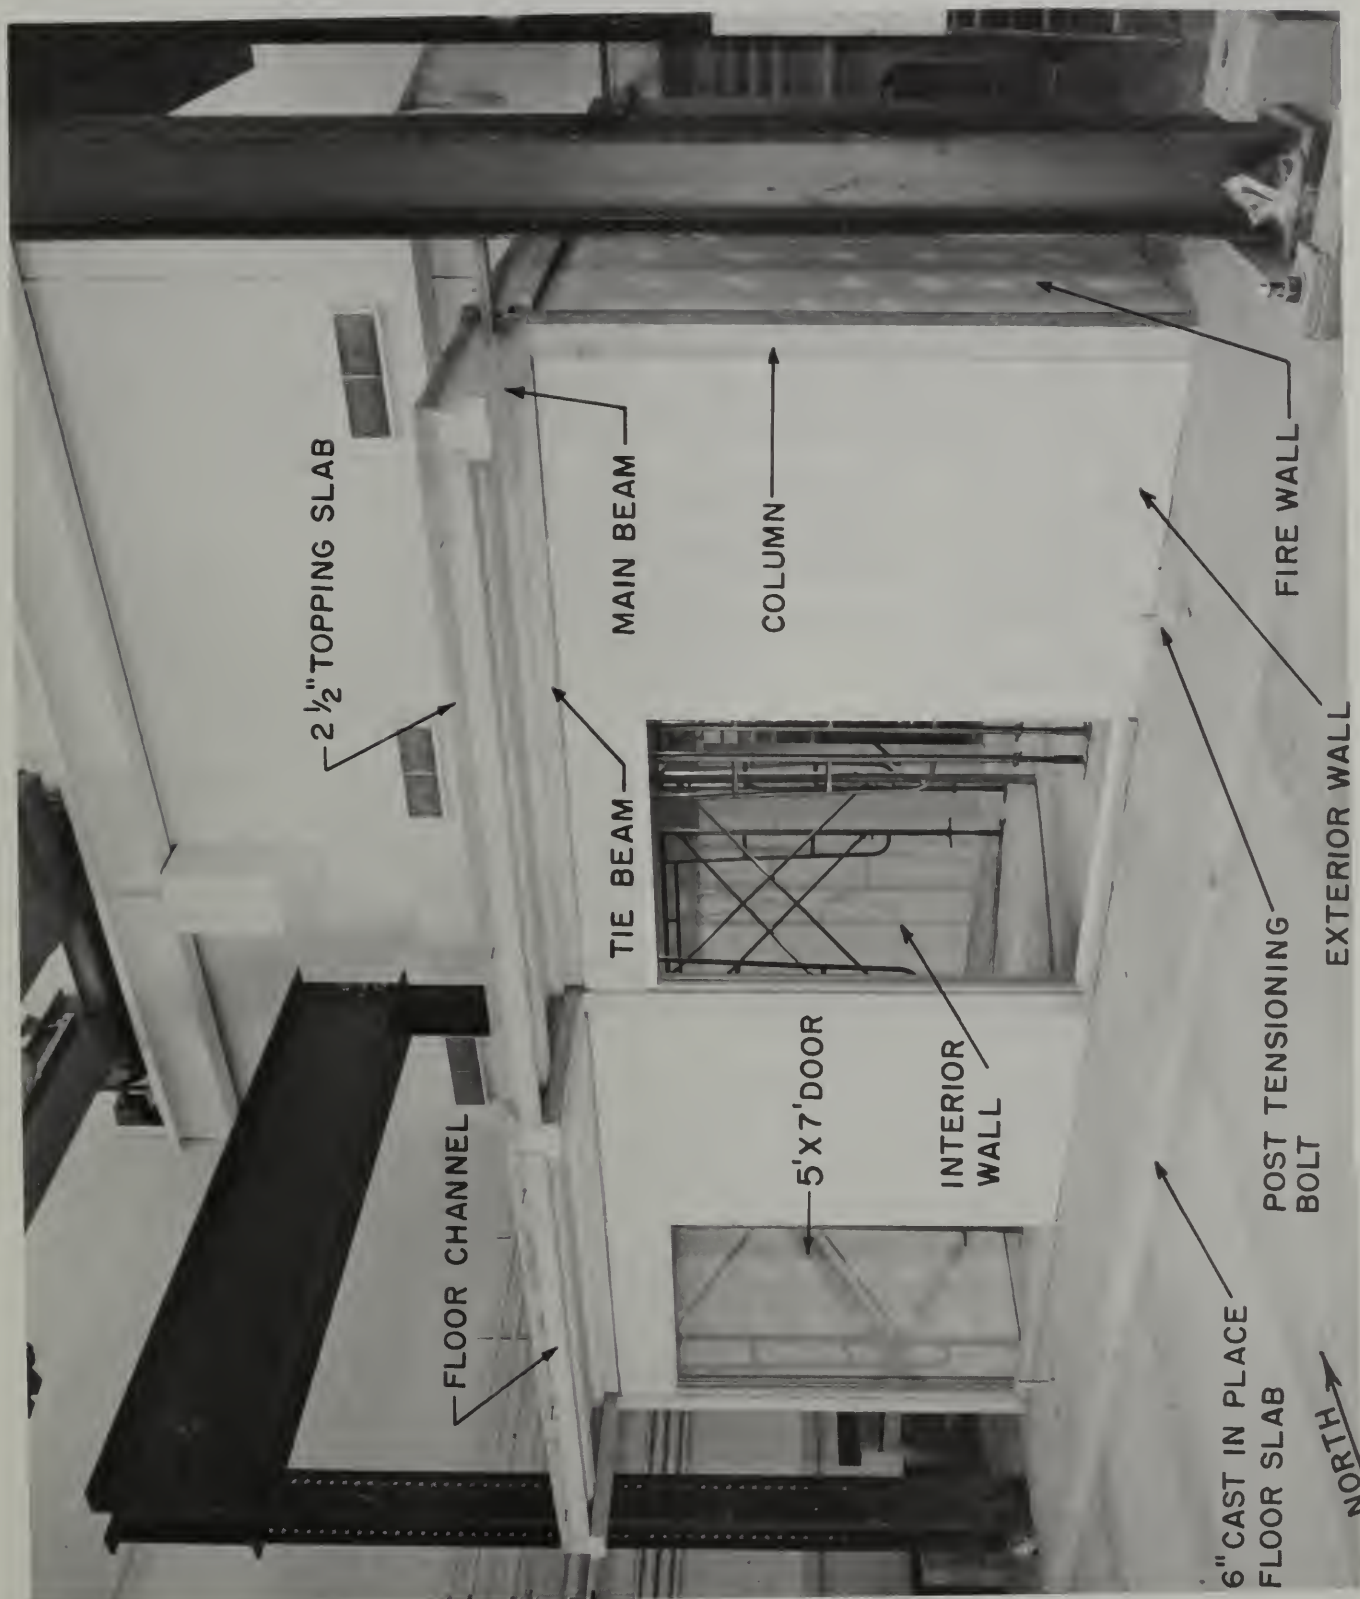
Fig. 5.22 The test structure after the installation of walls

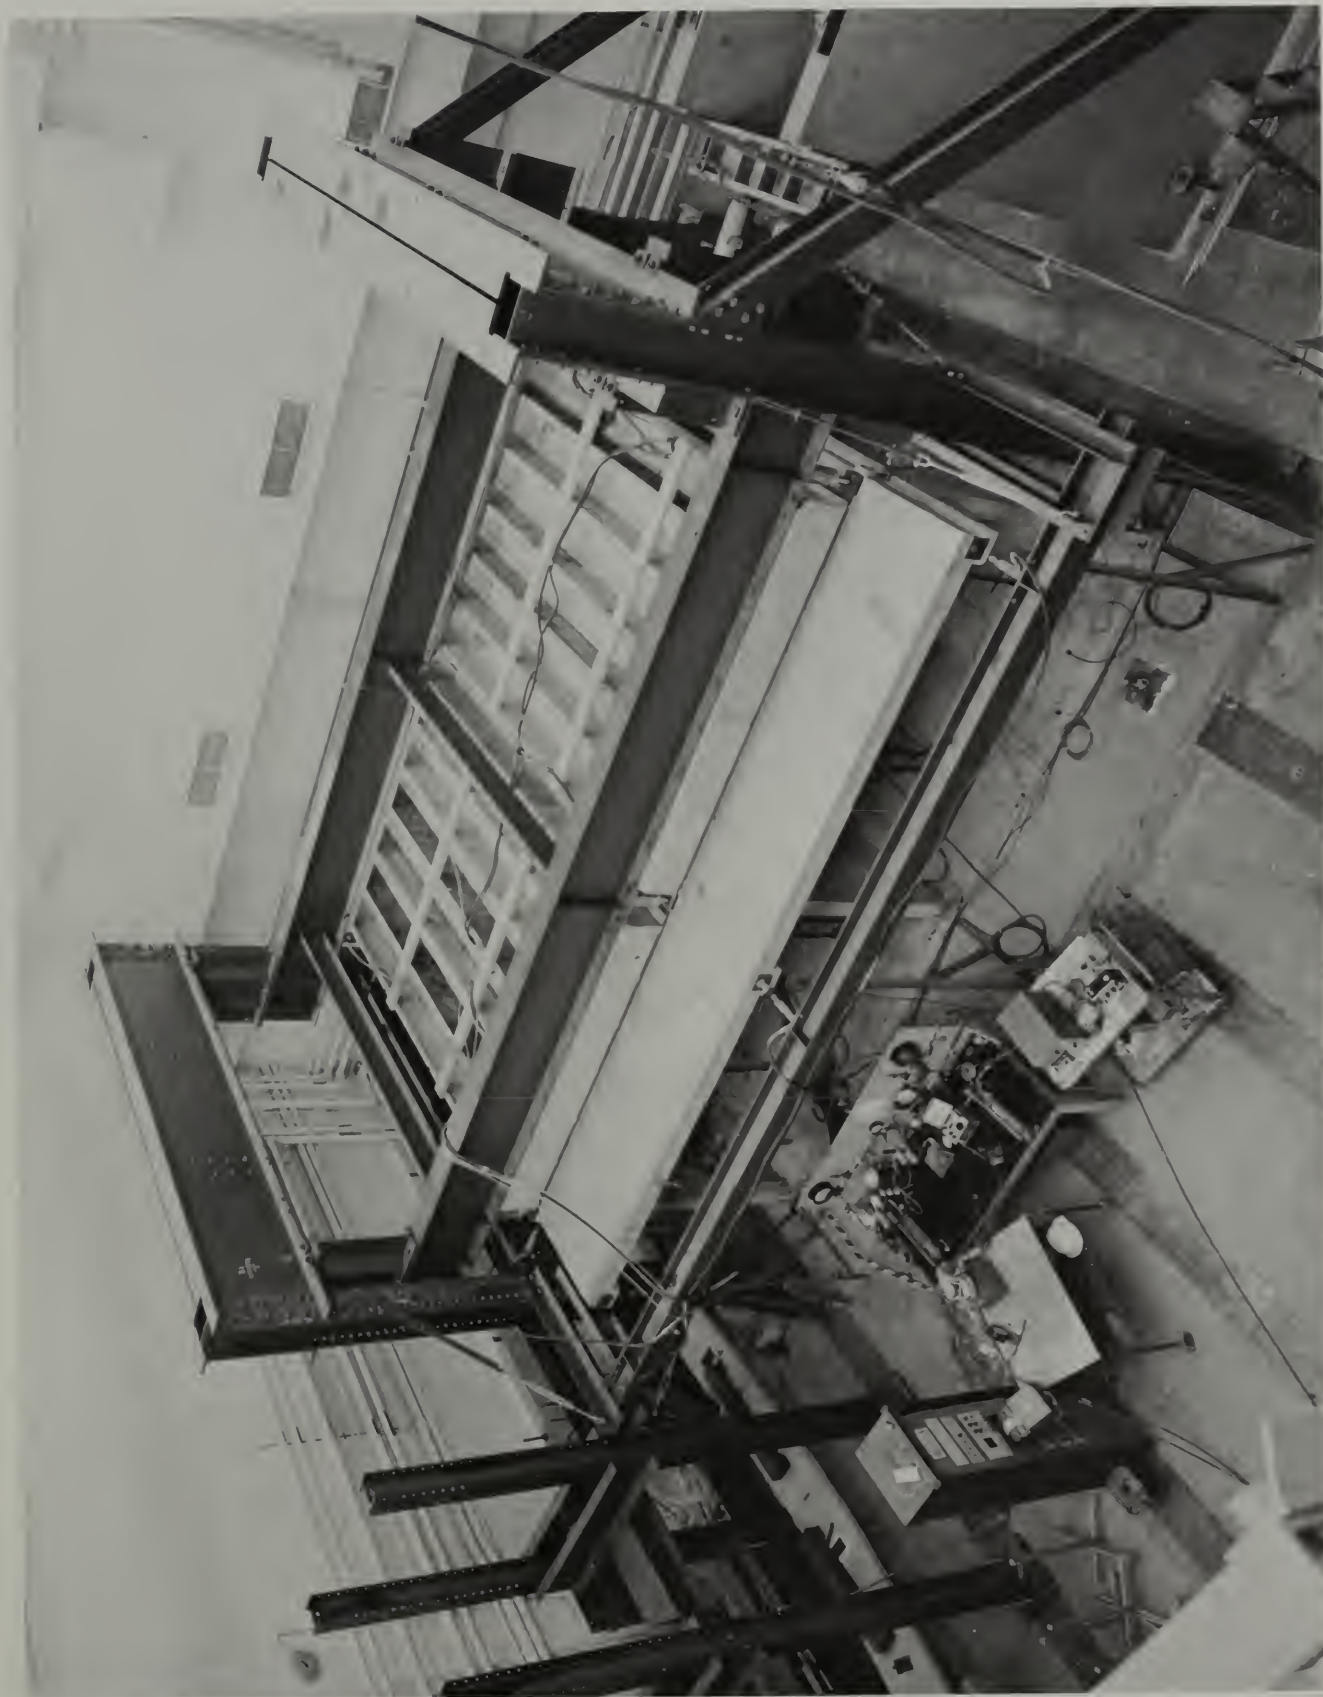
Fig. 5.23 The test structure with testing equipment installed (top view)

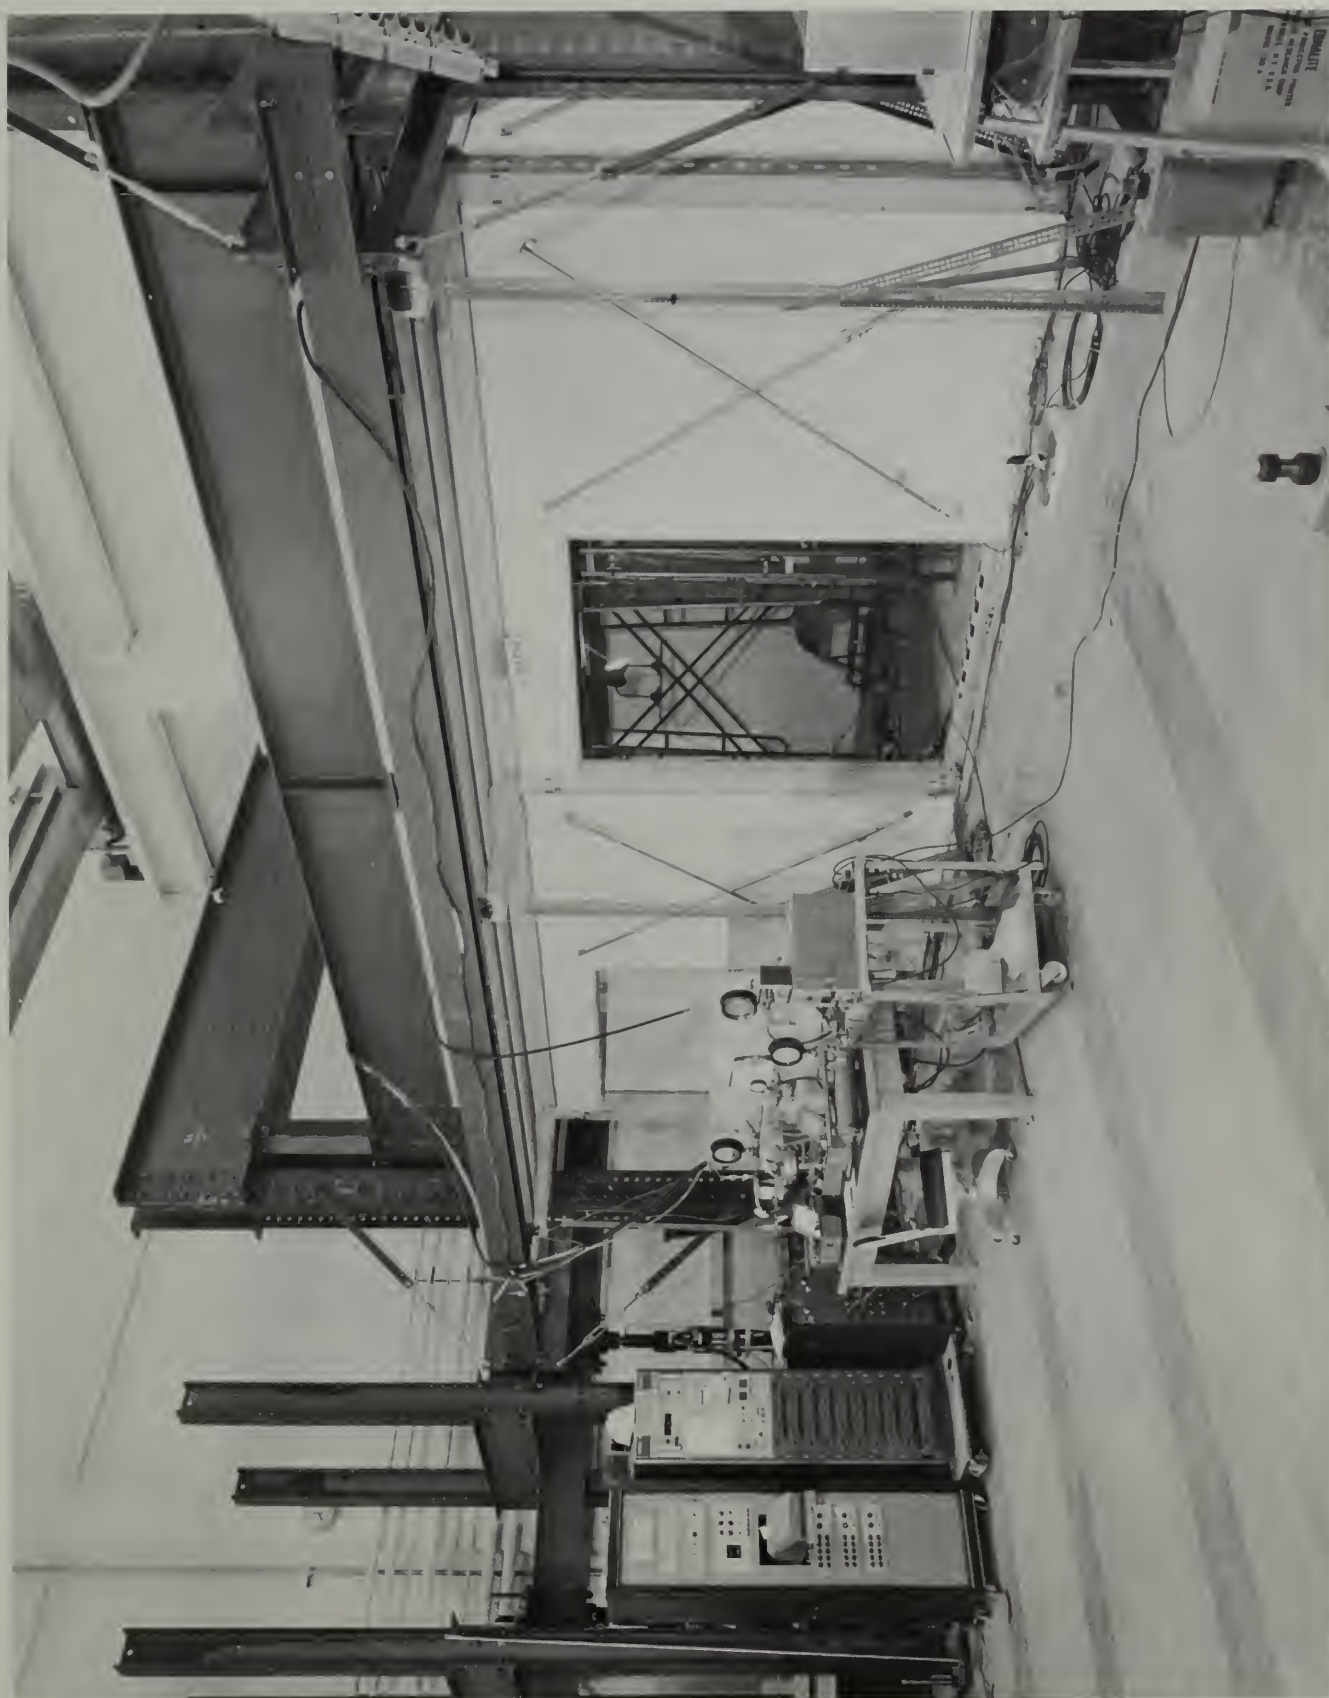
Fig. 5.24 Test structure with testing equipment installed (front view)

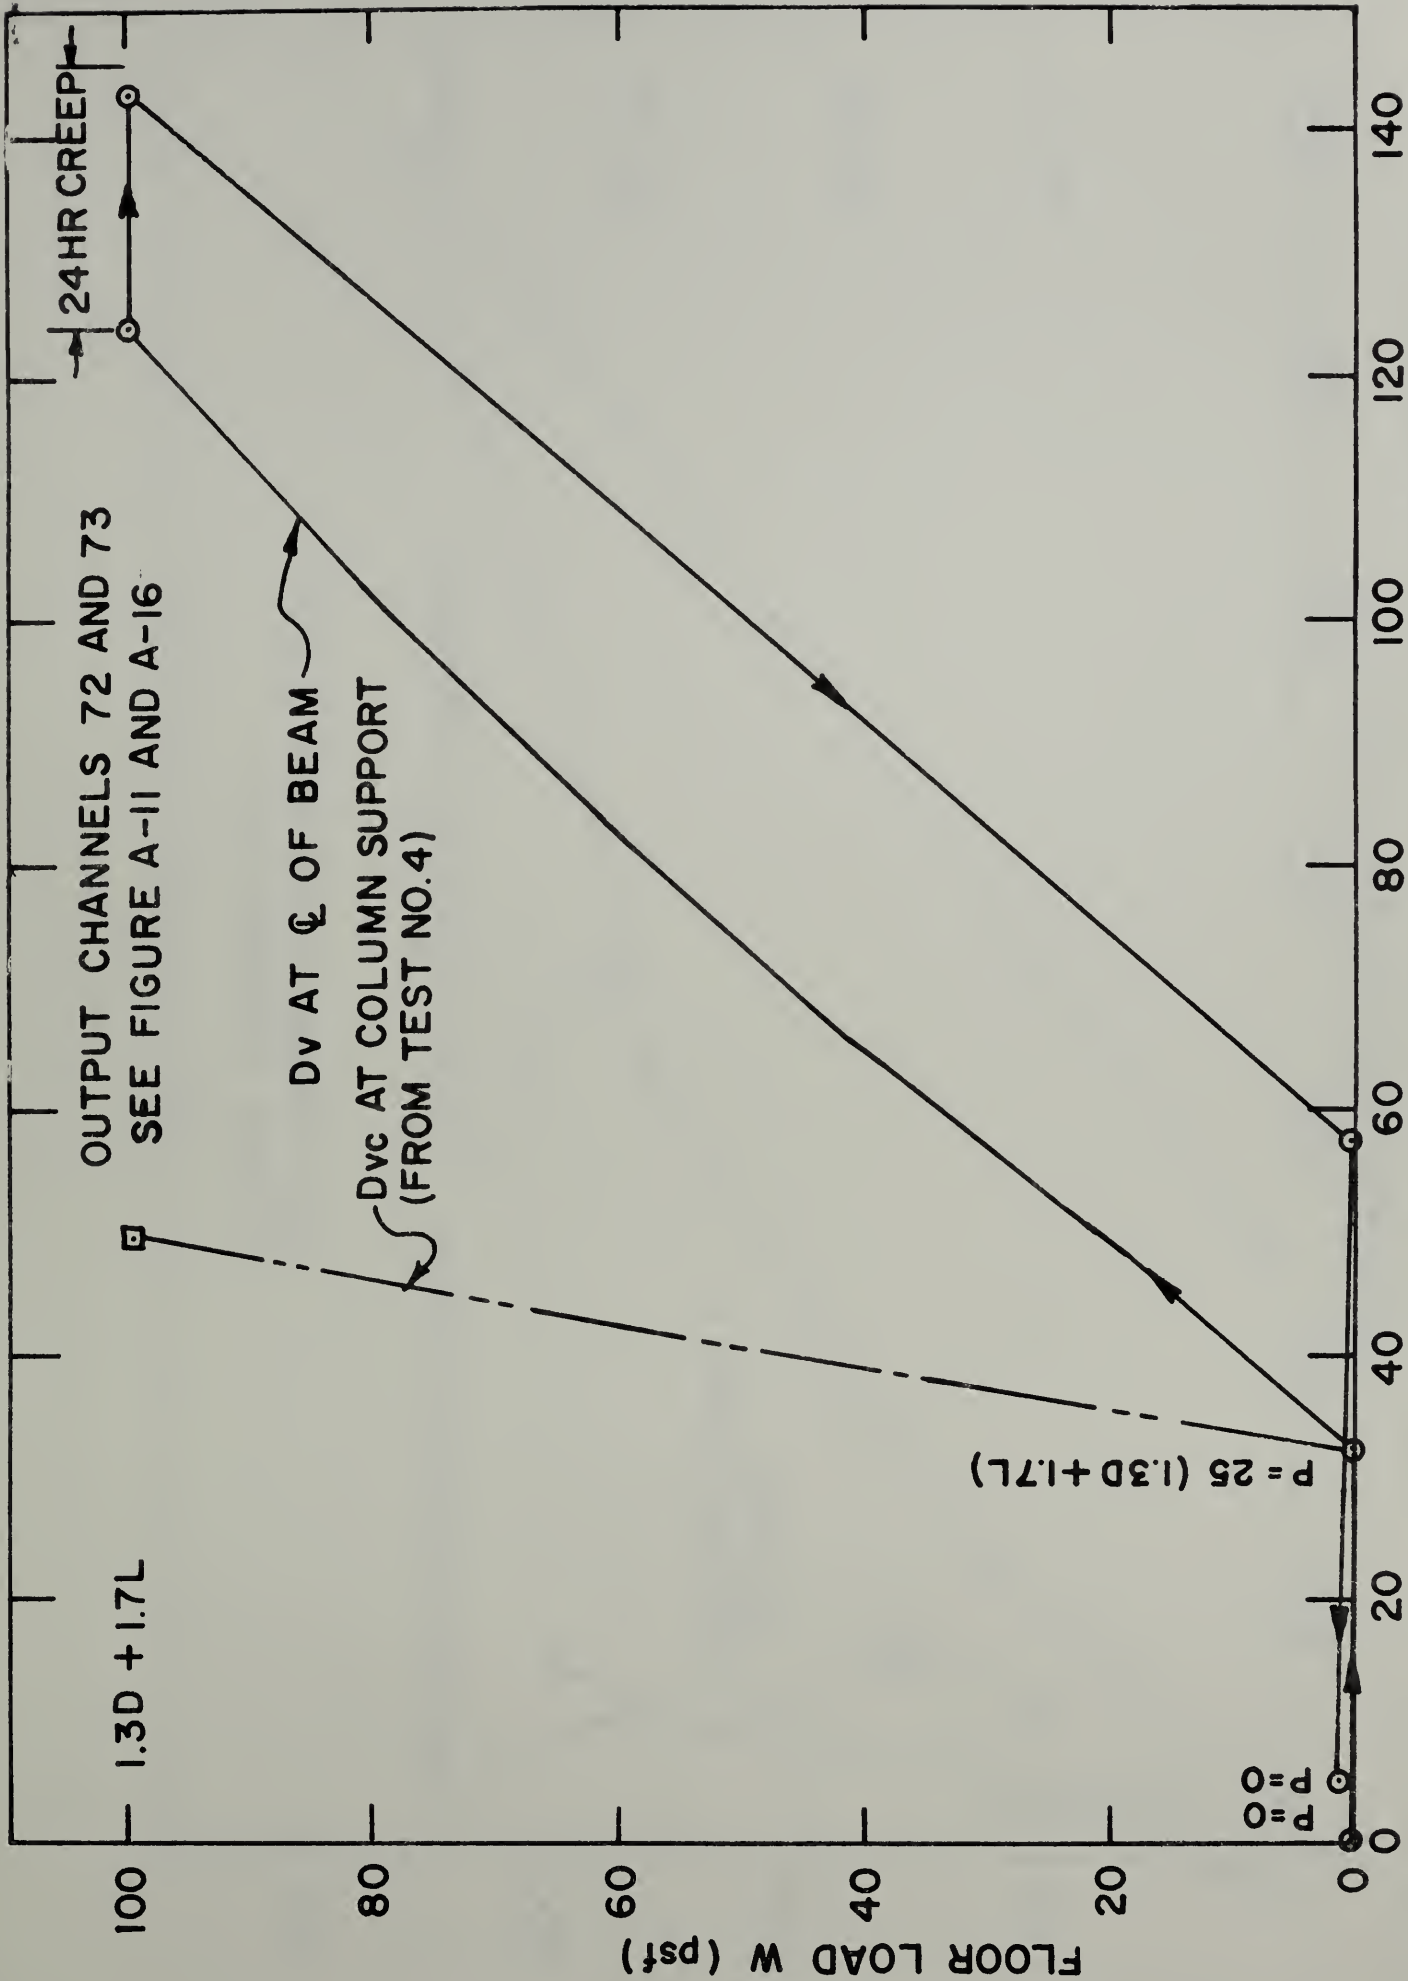
FIGURE NO. 9.1-TEST NO. 5, SUSTAINED VERTICAL LOAD VS MIDS PAN DEFLECTION OF CENTER MAIN BEAM

- (1) The increasing load-deformation curve for the load application portion of the cycle was reasonably linear, indicating elastic action
- (2) The 24 hour creep amounted to less than 0.02", which is only 7% of the permissible deflection set forth as a performance criterion and about 13% of the total observed deflection
- (3) Observed recovery was 96% (note that most of the creep deflection was recovered).

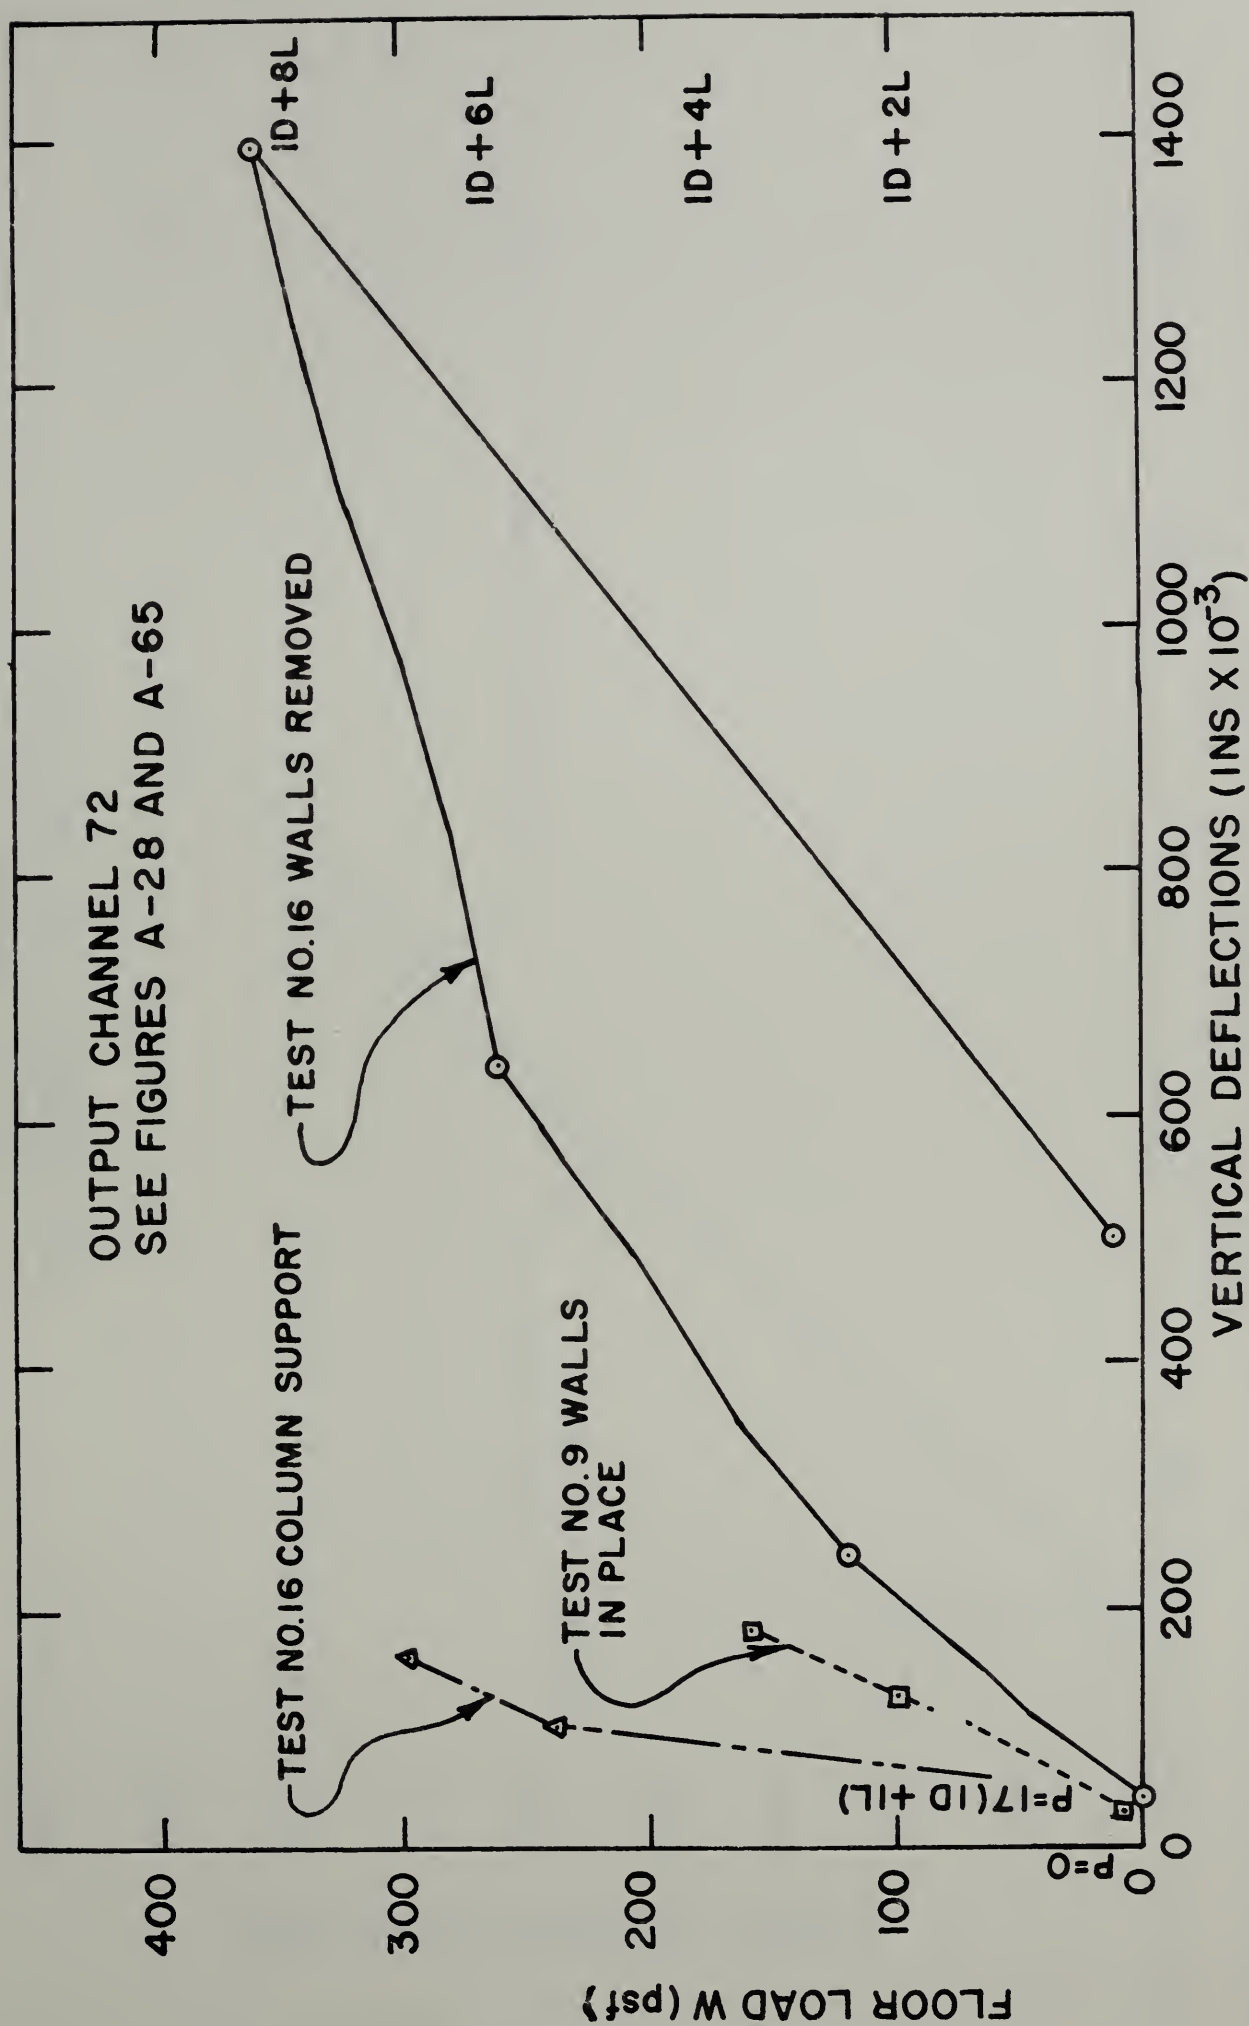
FIGURE NO. 9.2-TEST NO. 16, MAJOR FLOOR LOAD (W) VS. MIDSPAN DEFLECTION OF CENTER MAIN BEAM

Figure 9.2 shows the plot of midspan deflection of the center main beam during the application of a 370 psf load ($1D + 8.4L$) to the main floor span (Test 16). This load was applied after the application of $1D + 1L$ to the columns. This test was designed to be a destructive test of the floor system of the structure; however, the loading system (designed for 300 psf) failed before the test structure. The deflection at one of the beam supports is again plotted on this figure to illustrate the order of magnitude of the "net" deflections. Also shown is the curve for the center beam midspan deflection obtained in Test 9 with walls. In Test 9 the maximum applied floor load was 160 psf ($1D + 3.5L$). It is interesting to note the substantial

The structure was capable of carrying a load of 370 psf without experiencing failure (Fig. 9.2).

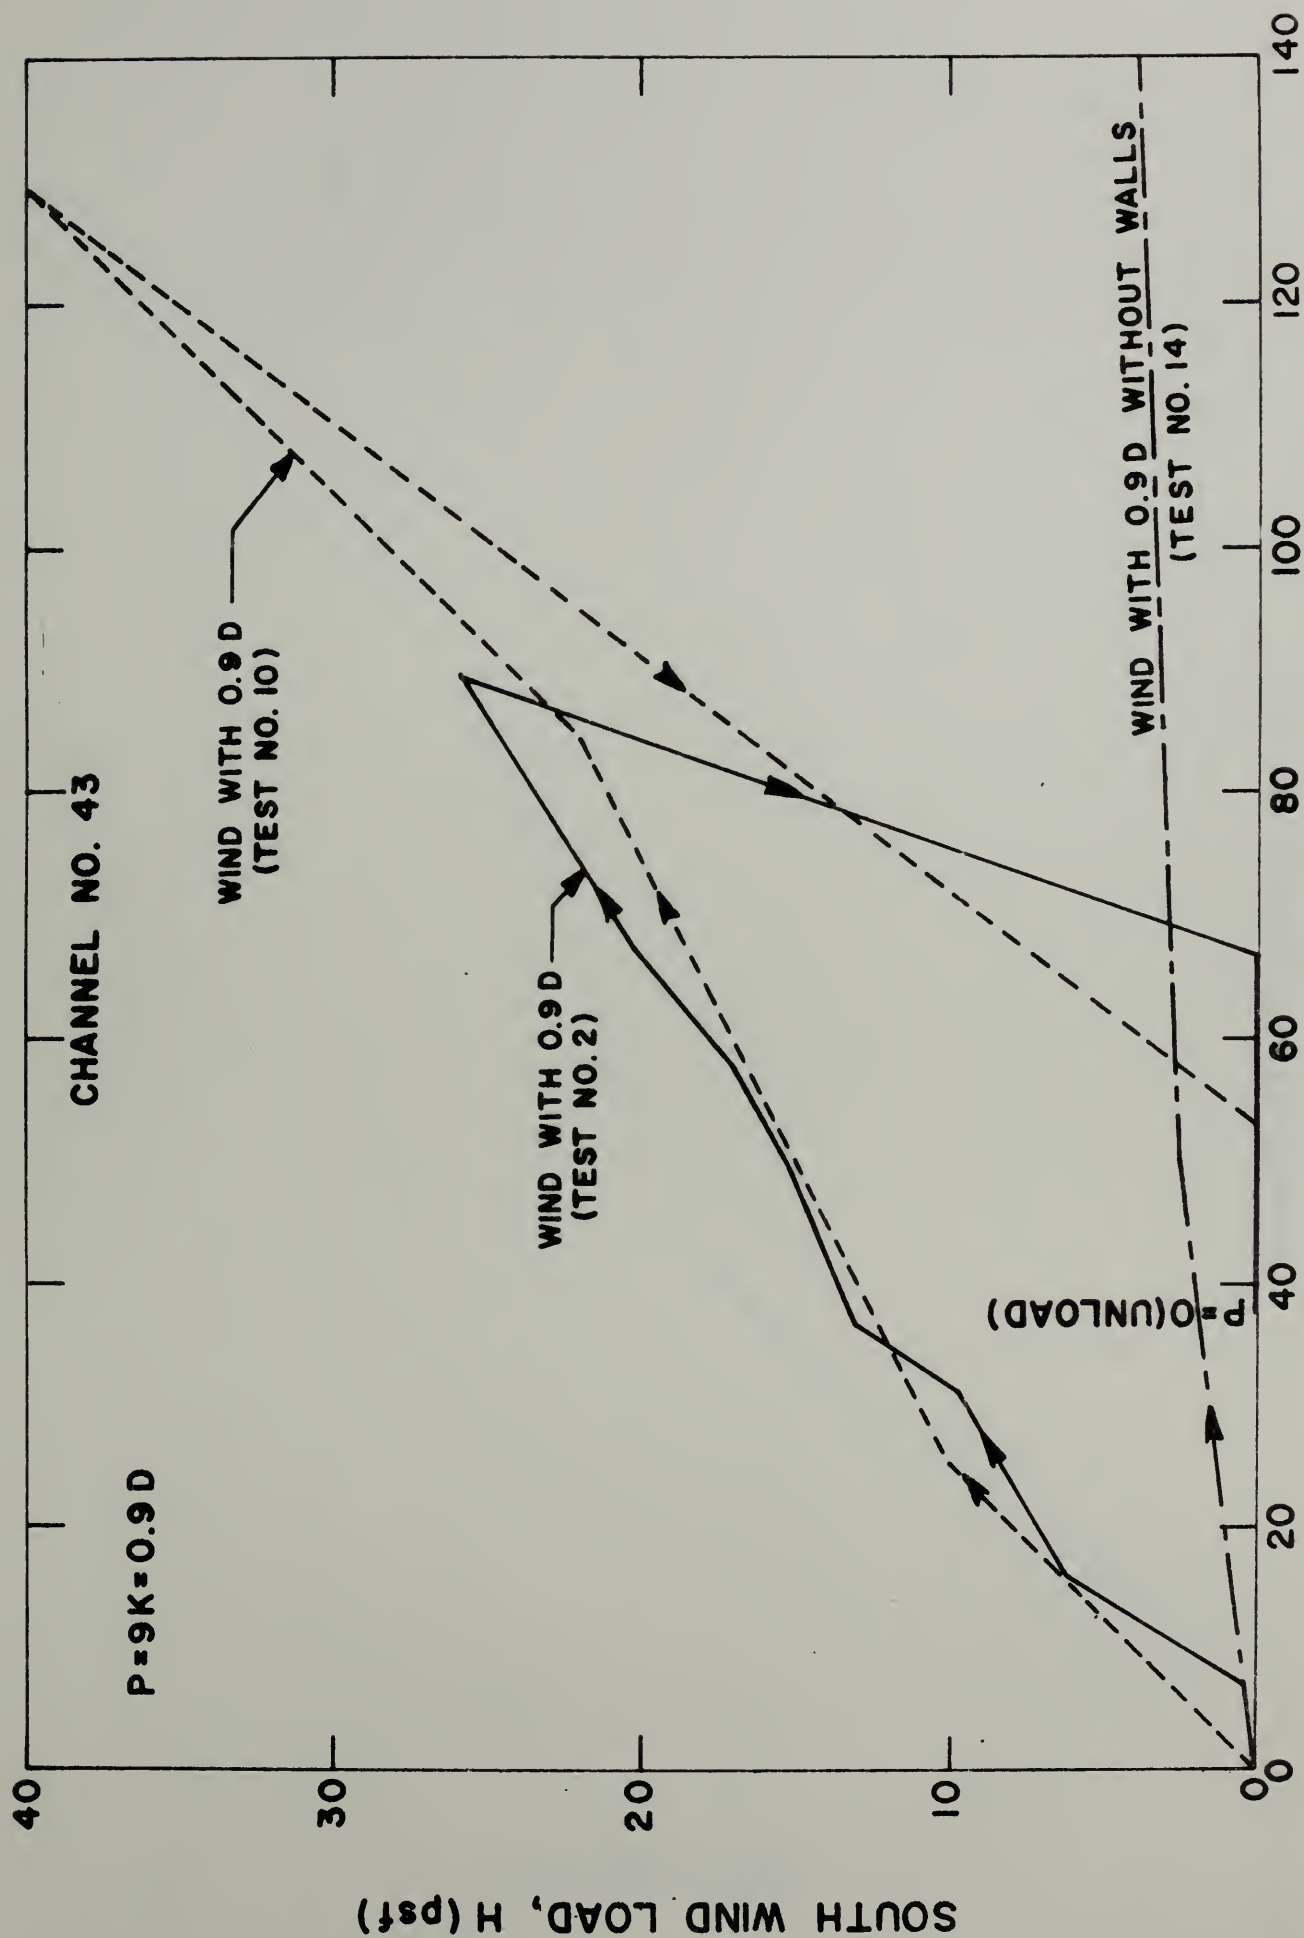
FIGURE NO. 9.9-N-S HORIZONTAL TRANSLATION OF STRUCTURE WITH AND WITHOUT WALLS

Referring to Fig. 9.9 no signs of distress were observed in the walls or other parts of the structure during Test 2. However at the upper limit of Test 10 some distress appeared in the form of bowing out (buckling) in compression areas near the corners of the wall panels. These signs of distress disappeared upon removal of the lateral load. After removal of the walls all connections between the walls and the frame were found to be in good condition, showing no dislocation of screws or anchorage devices. During Test 10 also there was some opening up of the joints between the columns and the wall panels in regions which would normally be subjected to tension by the development of diaphragm action in the walls. These openings were all less than 1/8" in width and tended to close partially upon removal of the load.

These racking tests were conducted with a superimposed column load of 0.9D acting alone. The results of the racking test in the S-N direction are illustrated in Fig. 9.7. This figure shows the development of lateral deflection measured at the level of the 2nd floor of the test structure during the application of loads simulating a wind pressure of 25 psf acting from the south. It may be noted from this figure that while overall deflection was small (0.091"), recovery was also small. Figure 9.8 shows the results of a later racking test which was carried to an equivalent of 60 psf windload. These two tests are simultaneously plotted in Fig. 9.9* and show good agreement.

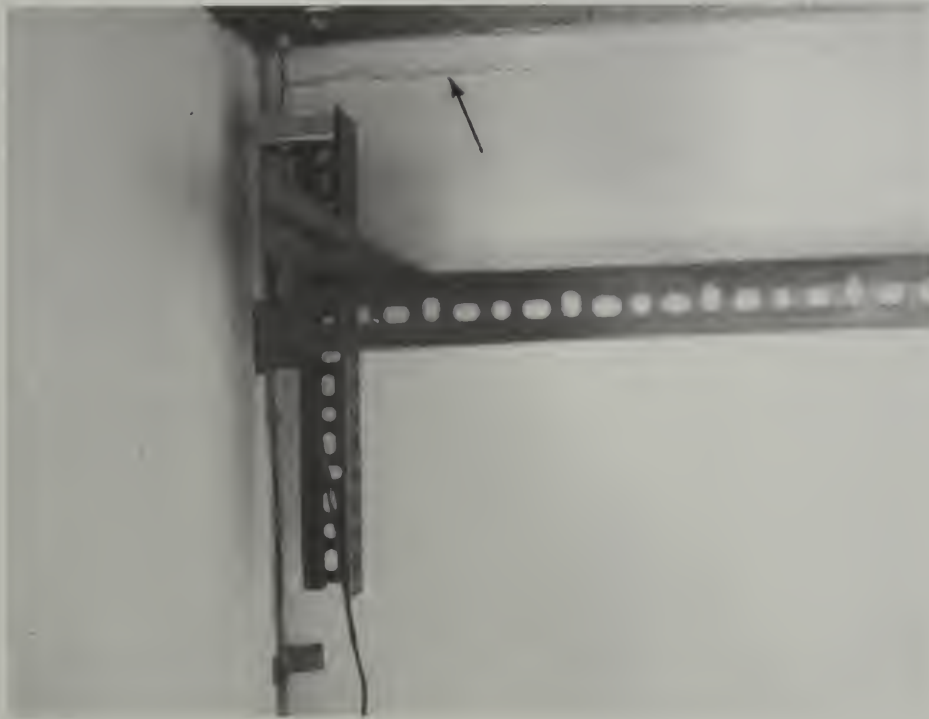
Fig. 9.22 Drywall crack near ceiling on interior side of east wall
